# Site Audit & Traffic Management Plan

Southern Cross University, Lismore

Colliers has been engaged by Southern Cross University (SCU) to undertake a safety audit and assessment of the existing campus in Lismore. The purpose of the project is to proactively seek to improve the safety of pedestrian and vehicular movements and operations throughout the campus.

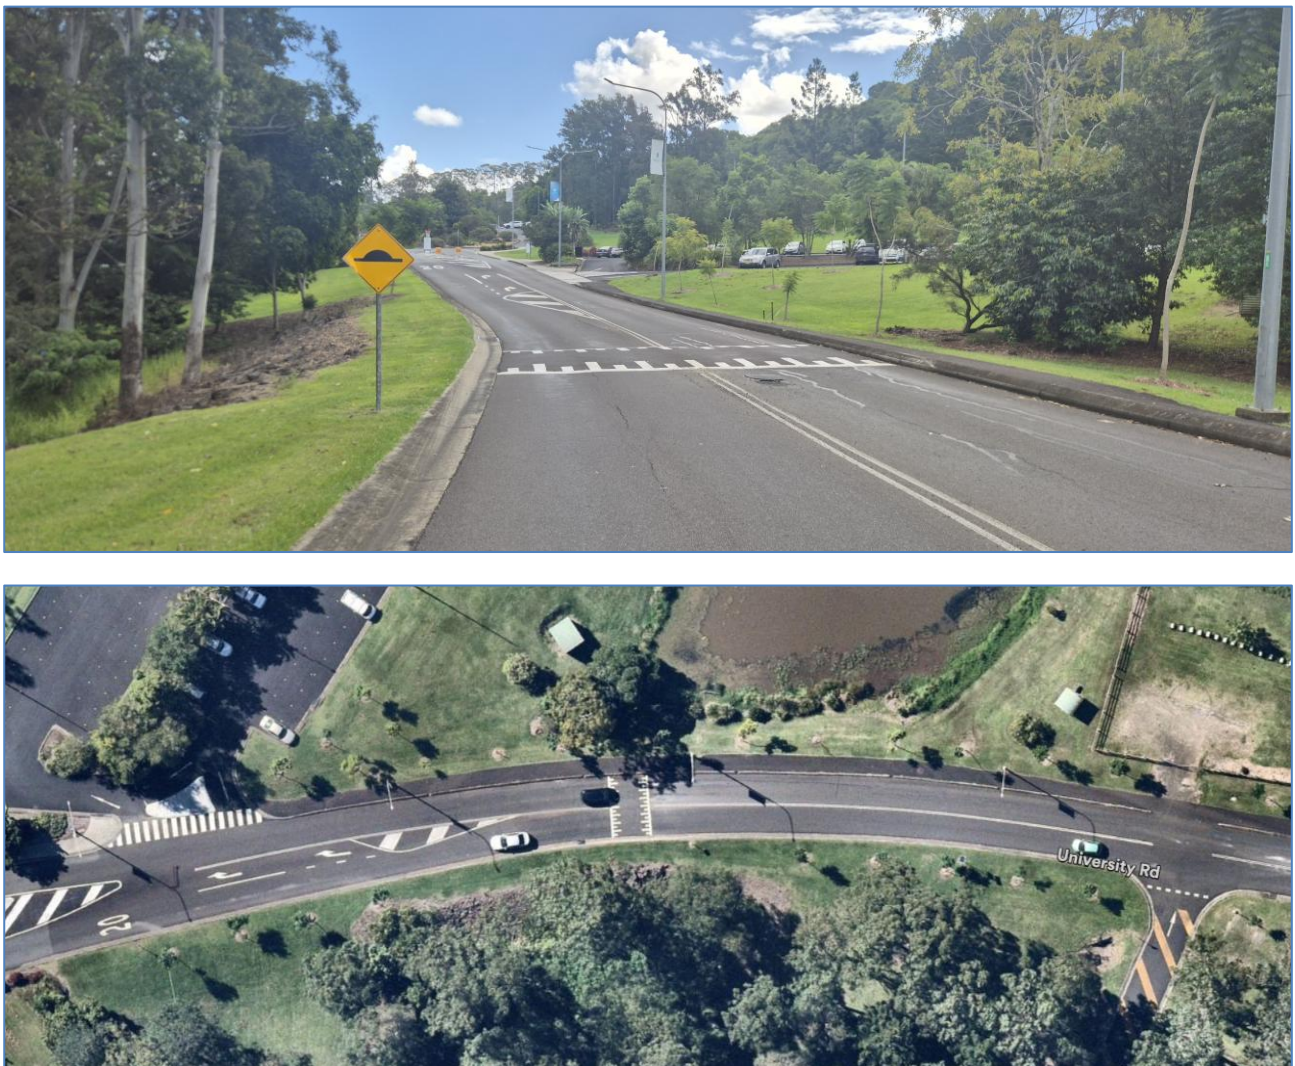
Figure 2.2: University Road (view westbound)

University Road accessed from Ballina Road (state highway) via a roundabout. It is subject to a 50 km/h speed limit outside the SCU campus site boundary and is marked with a 20 km/h speed limit within the campus. The road is a two lane (one in each direction), undivided local road. Carriageway widths vary between 7.3m and 8.0m. The topography of the road is such that there is an elevation drop of approximately 63m from Ballina Road to the site entry – this is equivalent to an average grade of 7.0% (1:14). The University new entry gateway signage is located 890m from Ballina Road, and immediately upon entry through the site gateway, the road grade increases to almost 16% (1:6.25).

Pedestrians are provided for via a dedicated route along the outbound side of the road. The pathway is formed as part of the road surface seal and is delineated from the traffic lanes via a surface mounted kerb as shown in Figure 2.2.

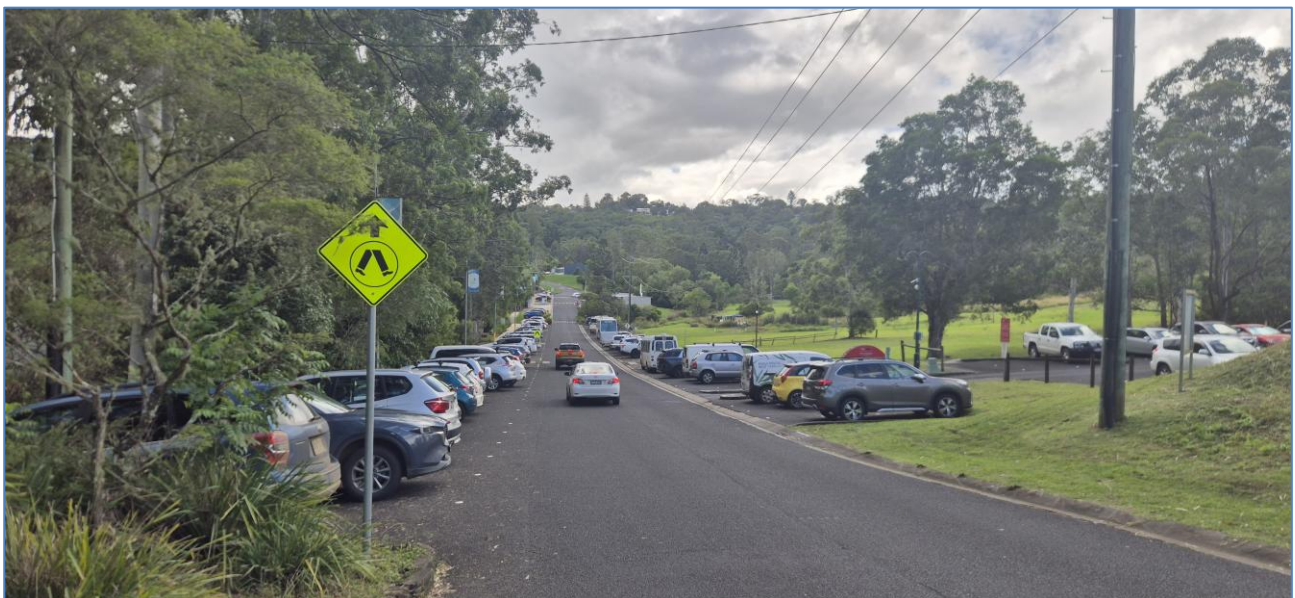
Figure 2.3: Rifle Range Road (view northbound)

Rifle Range Road accessed from Cynthia Wilson Drive (sub-arterial road) via a priority-controlled intersection. It is subject to a 50 km/h speed limit outside the SCU campus site boundary and is marked with a 20 km/h speed limit within the campus. The road is a two lane (one in each direction), undivided local (c class) road. Carriageway widths vary between 5.6m and 6.6m. The topography of the road is relatively flat with an average grade of less than 1% (1:100) up from Cynthia Wilson Drive to the north end of Rifle Range Road.

There is no formal footpath along Rifle Range Road between the Cynthia Wilson Drive intersection and the campus entry. At the campus entry, a footpath is provided along the western side of Rifle Range Road and extends northwards. A further footpath connects the student accommodation car park to the zebra crossing, which links to the footpath on the western side of Rifle Range Road.

Watts profile speed humps are provided at distances 88m, 325m and 460m from the intersection (the latter two are within the SCU site boundary).

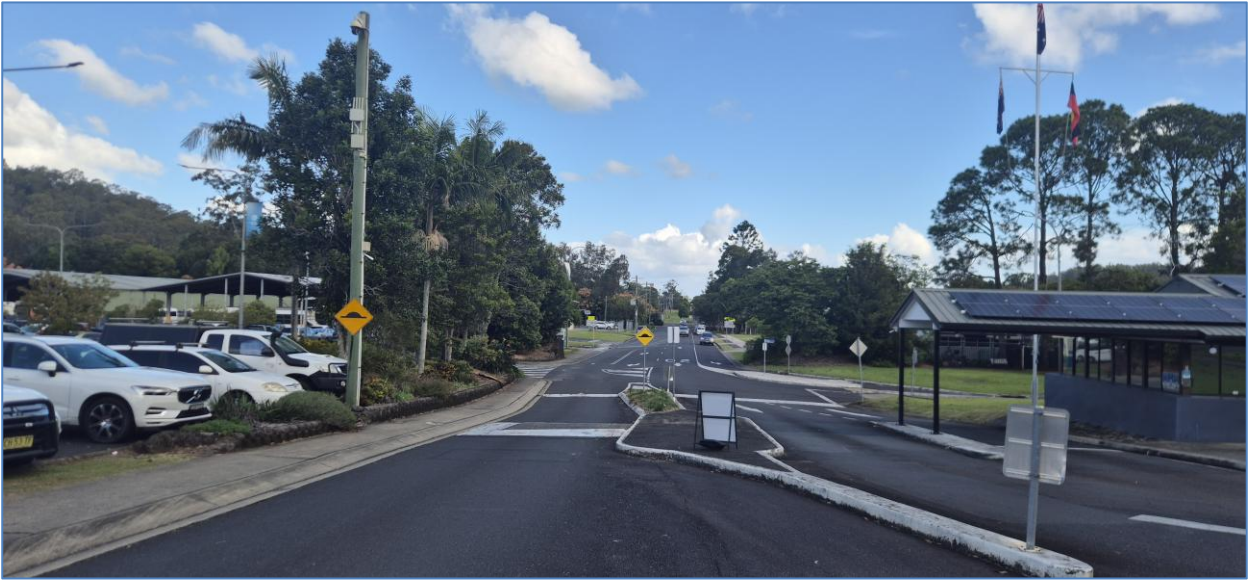
Figure 2.4: Military Road (view southbound)

Military Road provides the main access to the site. It is subject to a 50 km/h speed limit outside the SCU campus site boundary and is marked with a 20 km/h speed limit within the campus. The road is a two lane (one in each direction), undivided sub-arterial road with kerbside parking. Carriageway widths vary between 8.8m and 12.3m kerb to kerb – with through lanes varying between 8.8m and 9.5m. The topography of the road is relatively flat with an average grade of less than 1.5% (1:65) up from Dalley Street (sub-arterial road) to the north end of Military Road. A 20km/h road marking is provided at the site boundary to SCU Lismore campus. Pedestrians are then provided for via a dedicated footpath on the western side of the road within the verge.

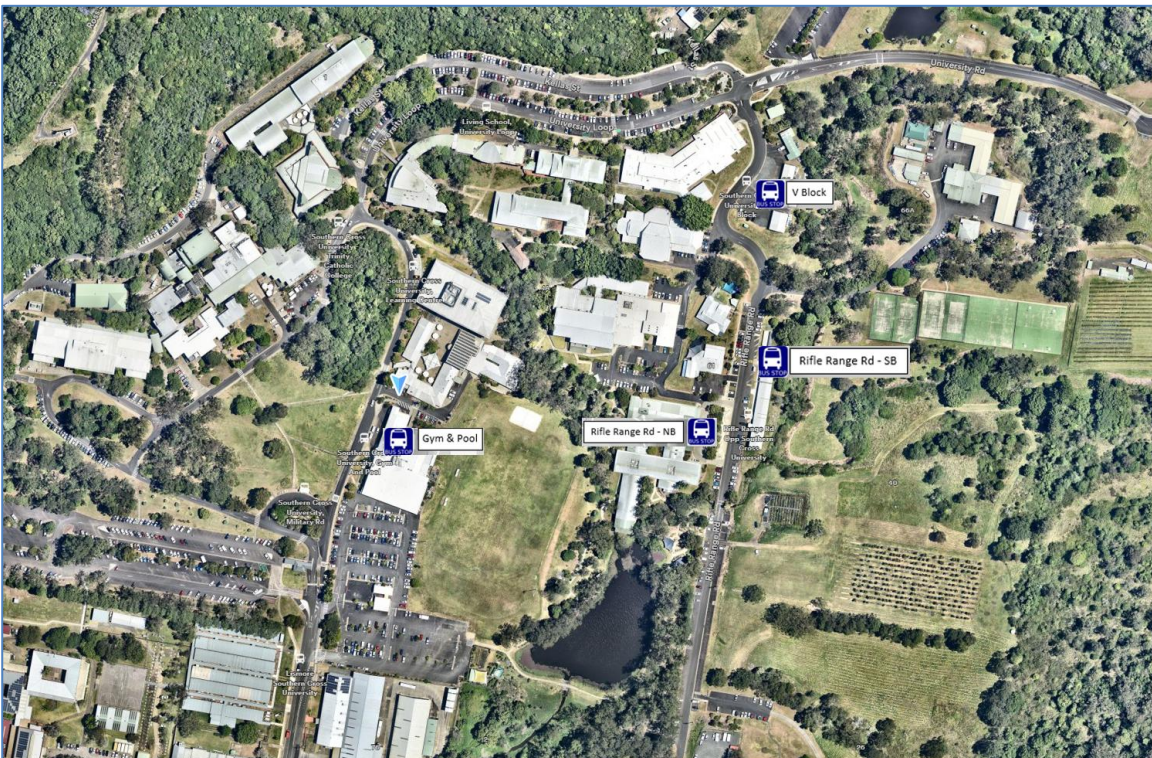
Figure 2.5: Bus stop locations

The SCU Lismore campus is serviced by a number of bus routes operated by Northern Rivers Buslines and Blanch's Bus Company. A review of Transport for NSW (TfNSW) bus routes and timetable information (observed 12 July 2026) identify five stops within the campus. These are presented in Figure 2.5 and Table 2.1.

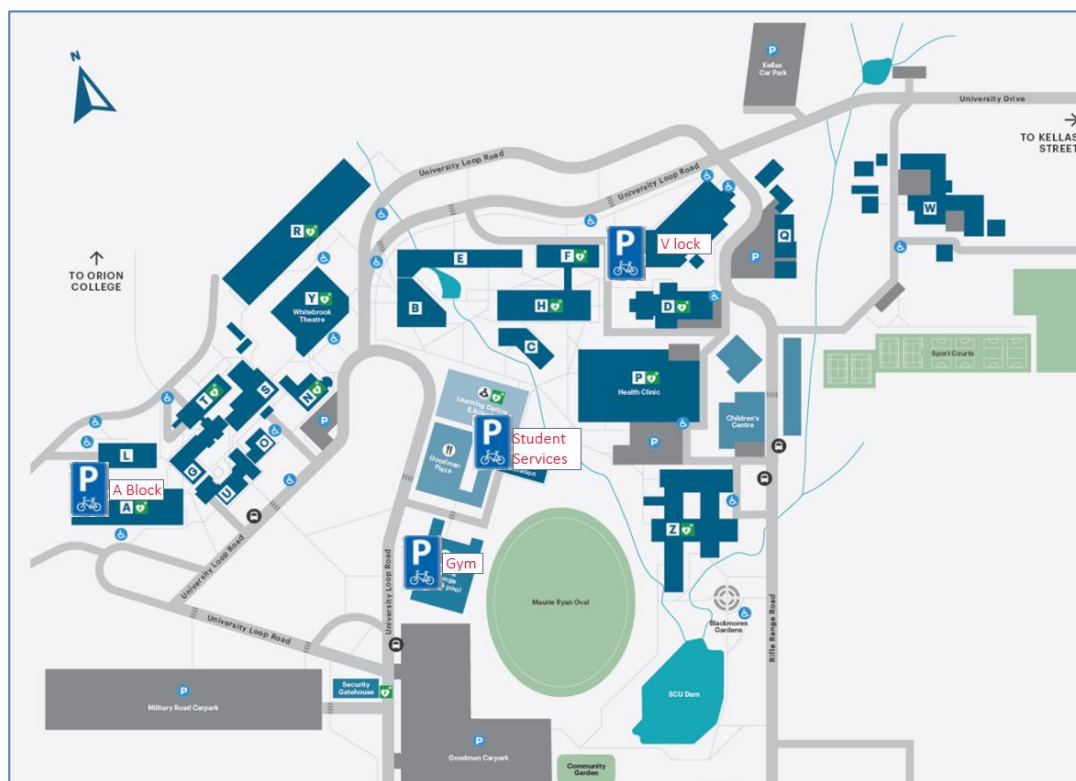
Figure 2.8: Cycle parking locations

Cycle parking racks are located at a number of locations throughout the campus. The cycle parking facilities are located outside the Gymnasium, Student Services and Blocks A and V.. These locations are shown in Figure 2.8. All racks are ground mounted and allow for front and rear wheel locking of cycles.

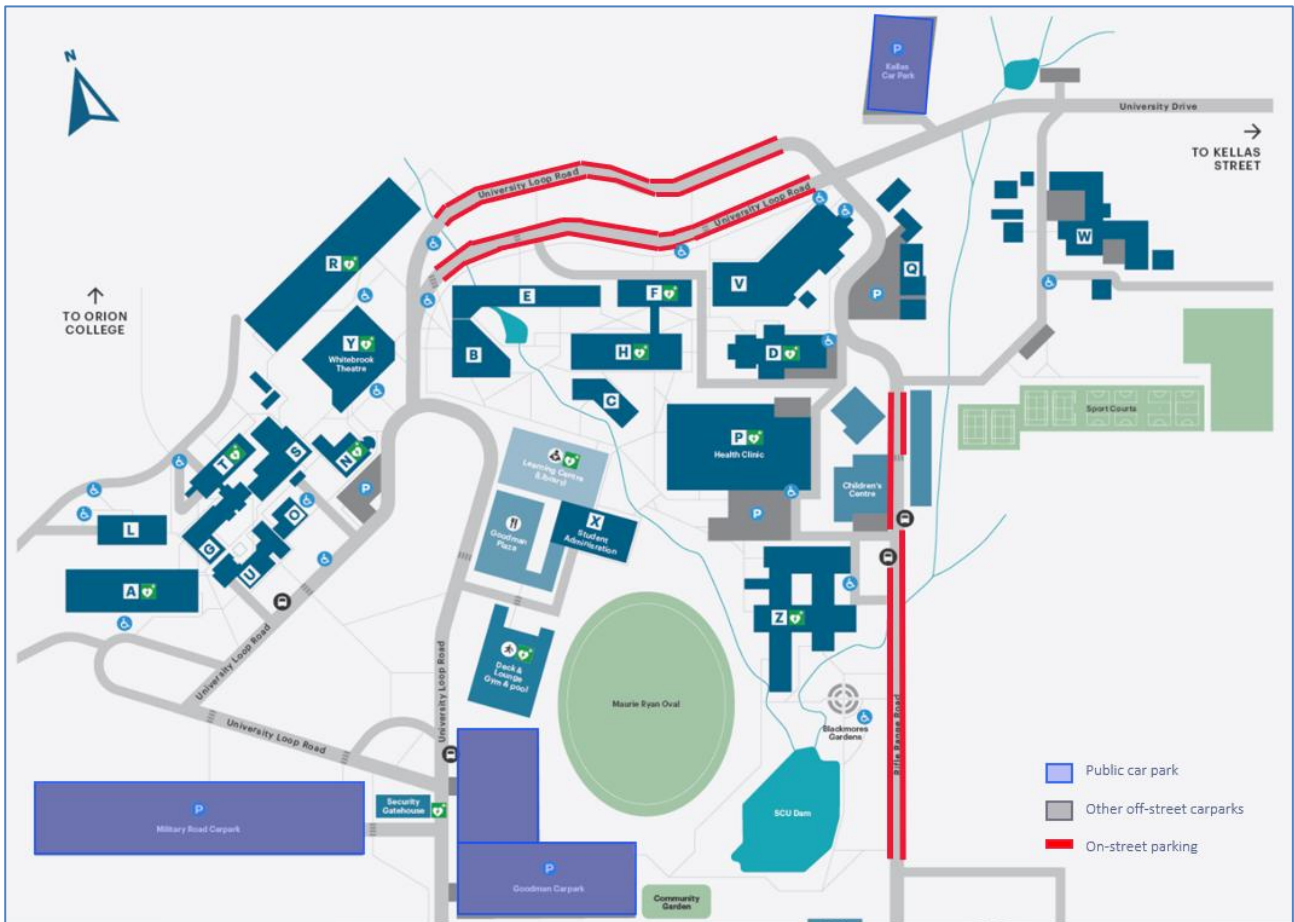
Figure 2.9: Car park locations

There are three public car parks located near the site entry points, comprising one car park accessed from University Road and two car parks accessed from Military Road.

In addition to the public car parks and other off street parking areas, on-street parking areas are located along University Loop and Rifle Range Road. Accessible car parking and loading zones are available in close proximity to the buildings. The locations of the off-street and on-street car parks are presented in Figure 2.9.

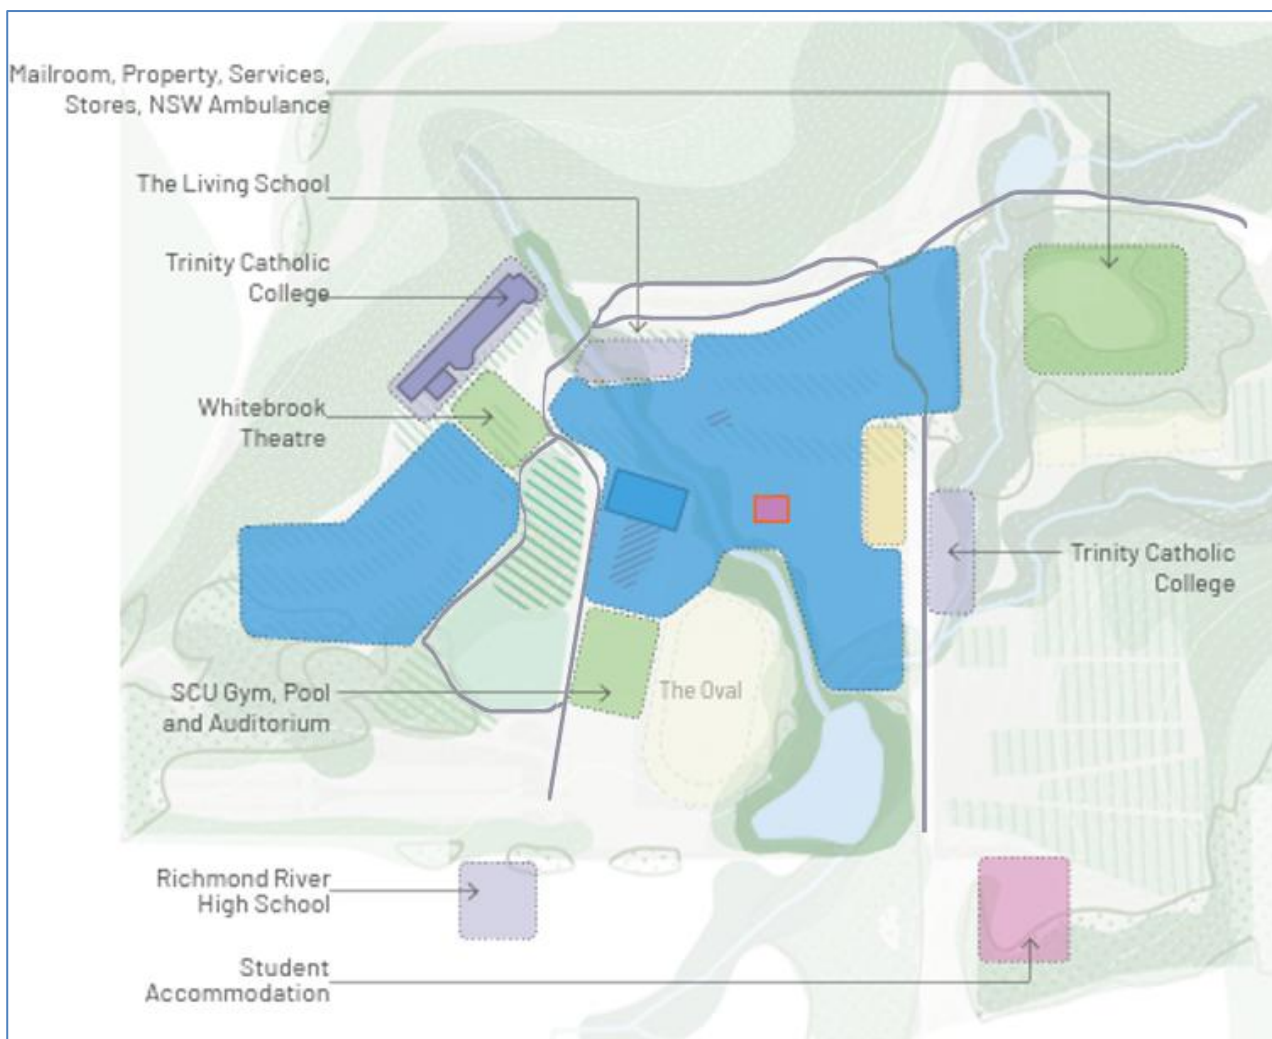
Figure 3.1: Current Map of the Site

Figure 3.1 and Figure 3.2 illustrates the current map and proposed Master Plan Map of the site.

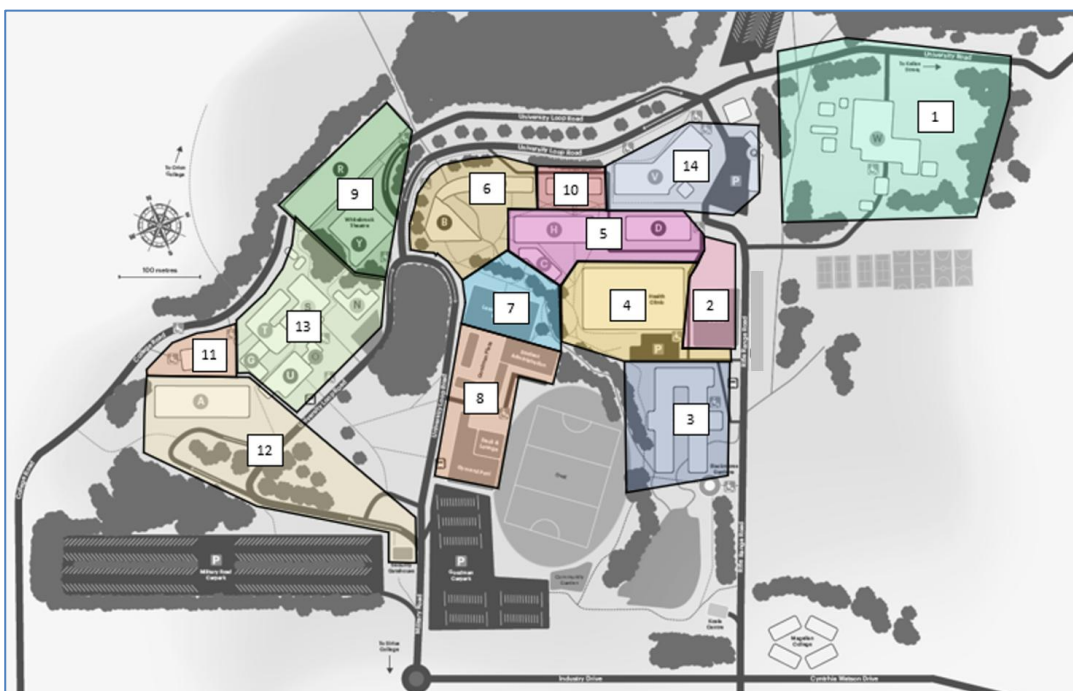
### Figure 4.1: Site Areas Map

A summary of the key risk assessment findings and recommended treatments is provided in the Risk Register presented in Table 4.5. For ease of identification, the site has been apportioned into 14 key areas as identified in Figure 4.1 below.

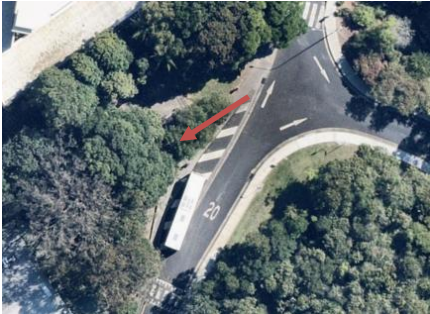
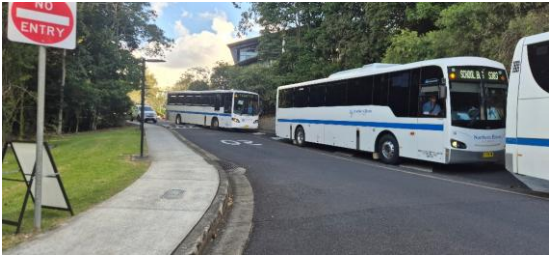
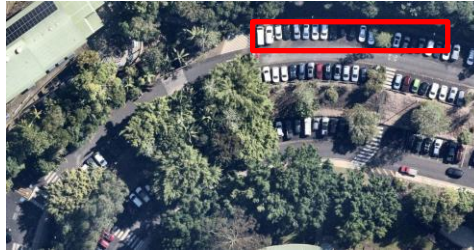
| No. | Risk Item | Location on Site Area Plan | Risk Description | Risk Level | Risk Mitigation | Risk Level- Post - Mitigation | Timing of Implementation | Priority Level |
|---|---|---|---|---|---|---|---|---|
| 1 | Bus Parking Location Impeding Traffic Flow | University Loop | <p>The current bus parking arrangement on Kellas Street accommodates only one bus; however, up to three buses are currently parked in this area. This reduces the effective carriageway width and restricts the free flow of traffic along this section of road. The presence of parked buses narrows the available space for passing vehicles and may force drivers into conflict with oncoming traffic or pedestrians due to reduced visibility and obstructed sightlines. Buses regularly park and block visibility to the zebra crossing immediately to the north, which would increase the risk of a child being struck.</p> | <p><u>Severity:</u><br/>Serious<br/><u>Likelihood:</u><br/>Likely<br/><u>Outcome:</u><br/>Extreme (FSI)</p> | <p>Relocate bus parking to the proposed location (as shown below) within the Kellas Street carpark area to remove the conflict with through traffic. Car parking opposite to the proposed bus parking is to be staff parking only. The proposed location accommodates the swept path requirements for the bus. Provide appropriate bus parking signs and line markings at the new location. Assess impact on car parking supply and tree removal.</p> <p>A functional layout of the bus parking area at this proposed location is provided in Appendix A. Refer to Appendix A for further details.</p> | <p><u>Severity:</u><br/>Minor<br/><u>Likelihood:</u><br/>Unlikely<br/><u>Outcome:</u><br/>Low</p> | The implementation of the risk mitigation is considered as a priority due to potential risk. | 1 |

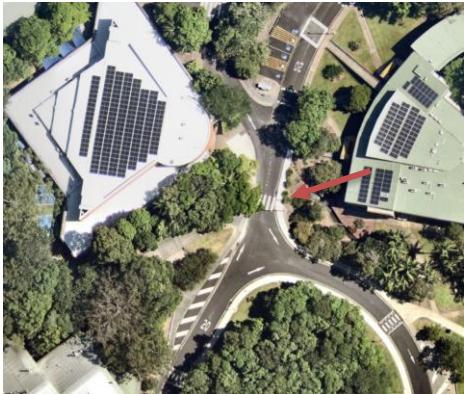
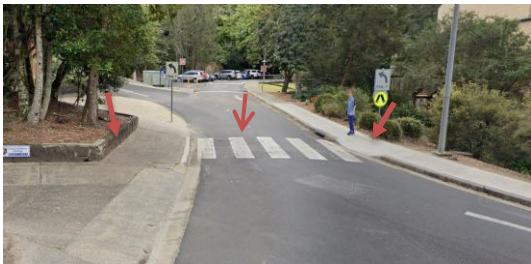
| 2 | Inadequate Crossing<br>Type: Zebra Crossing at school crossing | Areas 6 & 9 (University Loop) and Area 3 (Rifle Range Road) | <p>Pedestrian crossing is provided as zebra crossings in location of University Loop serving high volumes of school students. At Areas 6 and 9, the crossing is on a two-way road used by school students. The existing zebra crossing arrangement does not incorporate the required kerb ramps or Tactile Ground Surface Indicators (TGSi). Installation of compliant kerb ramps requires sufficient space for both the ramp transition (tie-in) to the roadway and the adjoining footpath width. The current crossing location lacks adequate space to accommodate these requirements. Accordingly, provision of additional footpath platform area (e.g. a concrete extension) will be necessary.</p> <div data-bbox="483 632 945 1027" data-label="Image"> </div> <div data-bbox="483 1046 1012 1310" data-label="Image"> </div> | <p><u>Severity:</u><br/>Moderate<br/><u>Likelihood:</u><br/>Possible<br/><u>Outcome:</u><br/>High</p> | <p>Upgrade zebra crossings at Areas 6, 9 and Area 3 to wombat crossings in accordance with relevant Austroads Guides and AS 1742.10. Ensure adequate stormwater drainage is incorporated. Adequate stormwater drainage must be incorporated into the design. The wombat crossing platform may be constructed using either bituminous or concrete materials, subject to project requirements and site condition. Review and raise sign heights at Area 3 as per AS 1742.2.</p> <div data-bbox="1294 632 1729 1241" data-label="Diagram"> </div> <p>Typical wombat crossing layout (Source: 1742.10)</p> | <p><u>Severity:</u><br/>Minor<br/><u>Likelihood:</u><br/>Unlikely<br/><u>Outcome:</u><br/>Low</p> | This particular mitigation measure is proposed as a short-term solution. In the long term, all zebra crossings at the site should be upgraded to wombat crossings to improve overall pedestrian safety. | 2 |

At Area 3 on Rifle Range Road, a zebra crossing is located immediately in front of a bus stop, creating a safety risk for crossing pedestrians. Signage height at Area 3 may also be insufficient given bus movements.

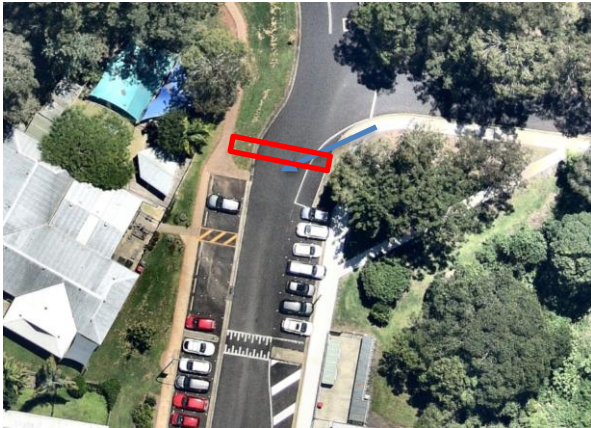
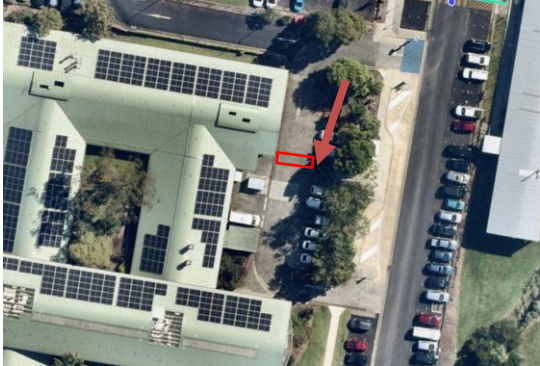
| 3 | Absence of Formal Pedestrian Crossing Facility | Area 2 (Childcare Centre, Rifle Range Road) | <p>At Area 2 on Rifle Range Road, in front of the childcare centre, there is no formal crossing for students to access the sports area. Furthermore, the absence of a designated crossing creates safety concerns for parents and children, including those with prams, particularly where parked vehicles on the eastern side result in additional visual obstructions.</p> <p>At the Living School car park in Area 2, no pedestrian crossing is provided to connect the pedestrian walkway between the bus stops and the Living School, which creates a safety concern for student movements.</p> | <p><u>Severity:</u><br/>Moderate<br/><u>Likelihood:</u><br/>Possible<br/><u>Outcome:</u><br/>High</p> | <p>Provide a wombat crossing on Rifle Range Road (Area 2), in front of the childcare centre and adjacent to the first parking bay. The crossing should ensure clear visibility in both directions and provide a safe, continuous connection between footpaths suitable for pedestrian use. The wombat crossing should be positioned clear of the parked vehicle turn-out manoeuvring area to avoid conflicts with pedestrian.</p> <p>Kerb ramps are to be provided at all new crossing locations in accordance with AS1428.</p> <p>A formal zebra crossing should be provided at the Living School car park to establish a safe pedestrian connection to the bus stop.</p> | <p><u>Severity:</u><br/>Moderate<br/><u>Likelihood:</u><br/>Rare<br/><u>Outcome:</u><br/>Low</p> | <p>This specific mitigation measure is proposed as a short-term solution. In the long term, all zebra crossings at the site should be upgraded to wombat crossings to improve overall pedestrian safety.</p> | 2 |

| | | | | | <p>Typical zebra crossing layout (Source: AS 1742.10)</p> | | | |

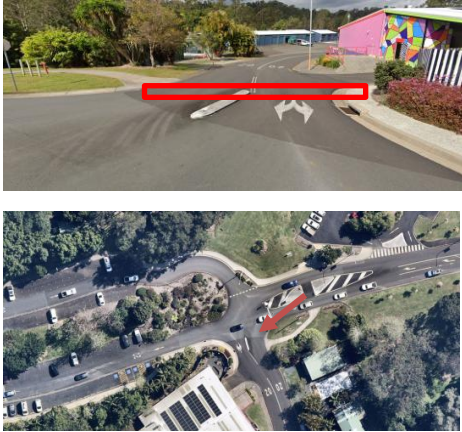
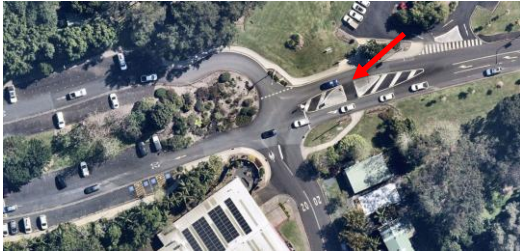
| 4 | Absence of Formal Pedestrian Crossing Facility | Area 14 University Road Intersection | <p>At Area 14, a footpath network exists along University Road, but no formal pedestrian crossing facility or refuge pedestrian crossing facility is provided at the Rifle Range Road intersection that would aid access to and from the northern car park.</p> | | <p>Provide a formal zebra crossing (short to medium-term) at Area 14 to connect the existing footpath network.</p> | | <p>This specific mitigation measure is proposed as a short-term solution. In the long term, all zebra crossings at the site should be upgraded to wombat crossings to improve overall pedestrian safety.</p> | 3 |

| | | | <p>At north of Area 14, the existing refuge pedestrian crossing will not function as a formal crossing for connectivity between the car parks and the university precinct to the south. Its current proximity to the intersection presents a potential safety risk.</p> | | <p>Provide a formal zebra crossing (short-term) or a wombat crossing (at long-term) to connect the car parks and the university precinct to the south.</p> | | | |

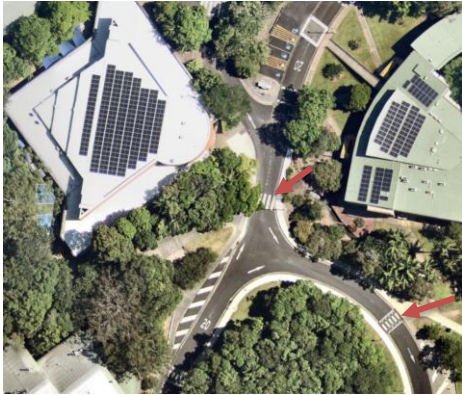
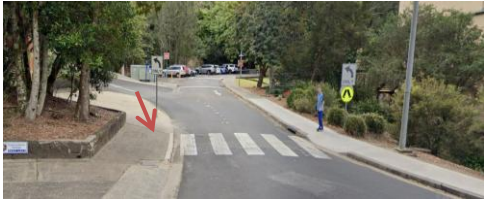
| 5 | Missing Pedestrian Crossing Signage | Areas 6 & 9 (University Loop) | <p>Pedestrian crossing signage is absent on one or both sides of the road at zebra and wombat crossing locations. The road operates as a two-way carriageway; however, signage is only provided in one direction, leaving approaching drivers from the opposing direction without adequate warning of the crossing ahead.</p> | <p><u>Severity:</u><br/>Moderate<br/><u>Likelihood:</u><br/>Possible<br/><u>Outcome:</u><br/>High</p> | <p>Install 'Pedestrian Crossing' warning signs on both sides of the road and in both directions (for two-way road) of travel at the crossing locations (where required). Ensure sign placement complies with AS 1742 lateral and longitudinal placement requirements.</p> <p>Signage location for wombat crossing or zebra crossing is shown below.</p> | <p><u>Severity:</u><br/>Moderate<br/><u>Likelihood:</u><br/>Rare<br/><u>Outcome:</u><br/>Low</p> | <p>This mitigation measure is not limited to the location shown and applies to all existing zebra crossings and wombat crossings at the site</p> | 2 |

Two-way road section of University Loop:

One-way road section University Loop:

Signage location of wombat crossing (Source: AS 1742.10)

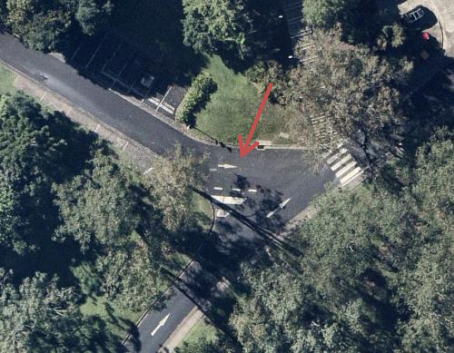
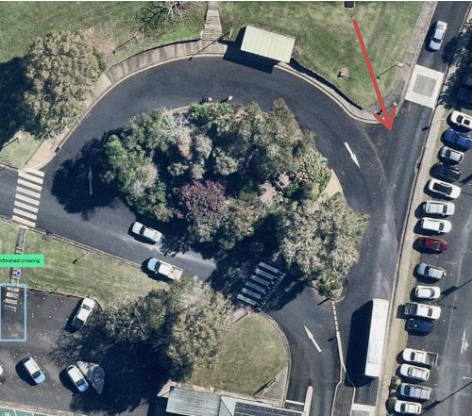
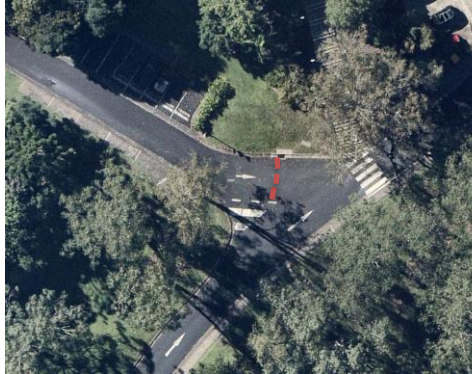
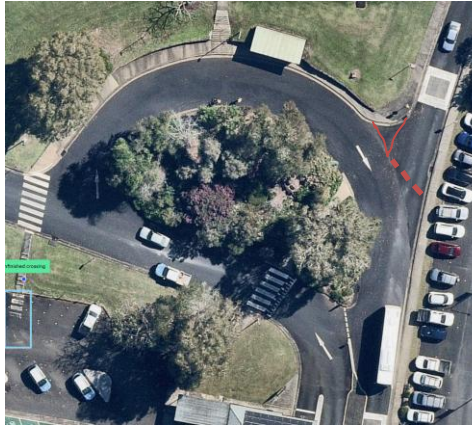
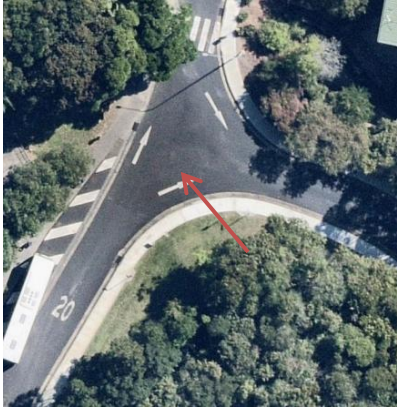
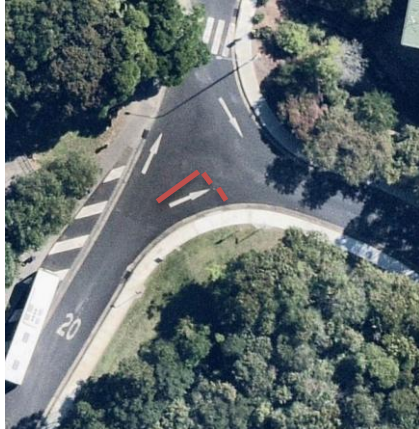
| 6 | Missing Give Way Hold Line Marking and Signage at Intersections | Areas 9 & 12 | <p>Give way line marking and associated signage are absent at intersection approaches in Areas 9 and 12. Without these controls, drivers have no clear indication of their priority status relative to other road users, creating ambiguity about right-of-way in a shared environment with pedestrians and cyclists. The intersection at Area 9 is used by school parents, so clear indication of the give-way to be provided to avoid any confusion or incident.</p> <p>Area12:</p> | <p><u>Severity:</u><br/>Moderate<br/><u>Likelihood:</u><br/>Possible<br/><u>Outcome:</u><br/>High</p> | <p>Install 'Give Way' signs and/or line markings at all shown intersection approaches in Areas 9 and 12, in accordance with AS 1742.2 and AS 1742.3.</p> <p>Location of Give-way Hold line in Area12:</p> | <p><u>Severity:</u><br/>Minor<br/><u>Likelihood:</u><br/>Unlikely<br/><u>Outcome:</u><br/>Low</p> | <p>This mitigation measure is not limited to the location shown and applies to all existing priority-controlled intersections at the site, where required.</p> | 2 |

| | | | <p>Area 9:</p> | | <p>Location of Give-way Hold line in Area 9:</p> | | | |

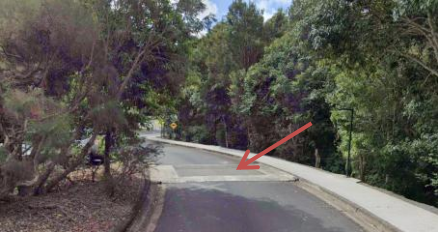
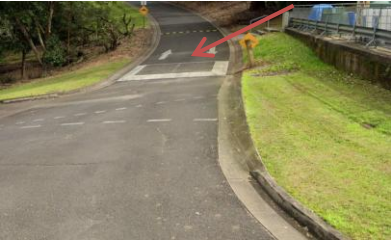
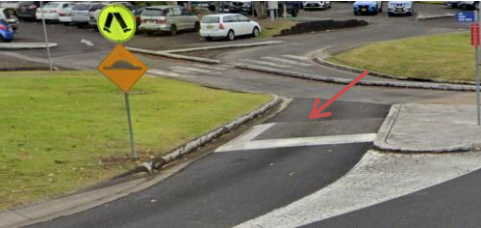
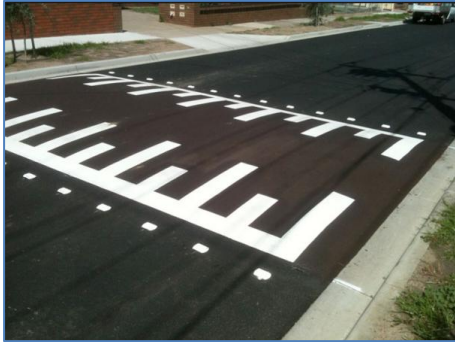
| 7 | Missing Signage and Pavement Marking at Raised Platforms | Areas 12, 13; Between Areas 6 & 9 | <p>Raised traffic platforms at multiple locations lack appropriate advance warning signage and required pavement markings. Drivers approaching these platforms, particularly at night may not receive adequate warning of the vertical change in road level, creating a risk of vehicle collision with the platform edge.</p> | <p><u>Severity:</u><br/>Minor<br/><u>Likelihood:</u><br/>Likely<br/><u>Outcome:</u><br/>Medium</p> | <p>Install advance warning signs in both directions at all raised platform locations in accordance with AS 1742.2. Provide retroreflective edge line markings and platform delineation.</p> <p>Typical raised platform layout (Source: AS 1742.2)</p> | <p><u>Severity:</u><br/>Minor<br/><u>Likelihood:</u><br/>Unlikely<br/><u>Outcome:</u><br/>Low</p> | <p>This mitigation measure is not limited to the location shown and applies to all existing raised platform at the site.</p> | 3 |

| | | | <p>Area 13:</p> <p>Area 12:</p> <p>Between Area 6 &amp; 9:</p> | | <p>Design Example:</p> | | |

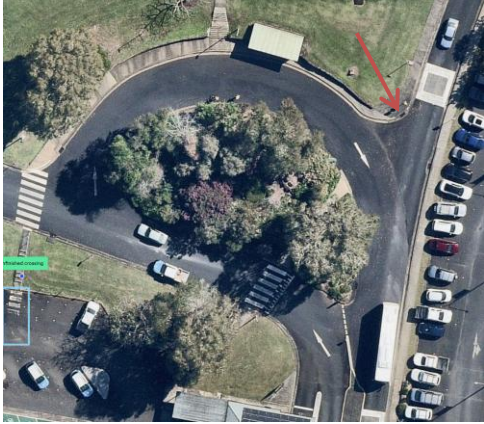
| 8 | Missing Directional Arrow Pavement Marking and 'No Entry' Signage on One-Way Road Exit | Area 12; Kellas Street Carpark Exit | <p>Directional arrow pavement markings are absent on one-way road sections at Area 12. While 'No Entry' signage is present, the absence of directional arrow markings on the carriageway means drivers, particularly those unfamiliar with the site may inadvertently travel in the wrong direction.</p> <p>Area 12:</p> | <p><u>Severity:</u><br/>Minor</p> <p><u>Likelihood:</u><br/>Possible</p> <p><u>Outcome:</u><br/>Medium</p> | Install directional arrow pavement markings at one-way road sections in Area 12, in accordance with AS 1742.2. | <p><u>Severity:</u><br/>Minor</p> <p><u>Likelihood:</u><br/>Rare</p> <p><u>Outcome:</u><br/>Negligible</p> | This mitigation measure is not limited to the location shown and applies to all one-way exit point. | 3 |

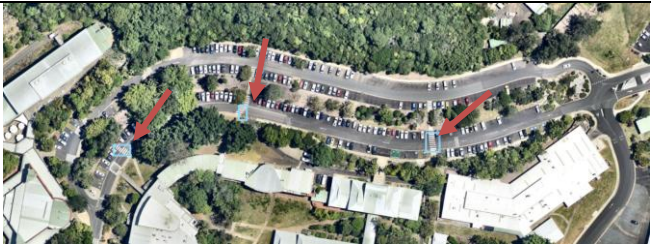
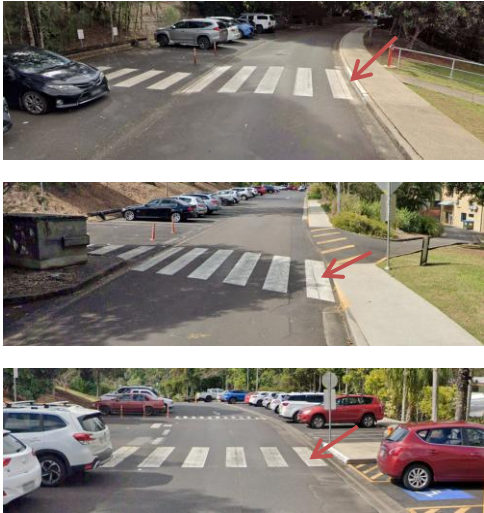
| 9 | Missing Kerb Ramps at Pedestrian Crossings | Kellas Street Carpark | <p>Kerb ramps are absent at zebra crossing locations at the Kellas Street carpark area. Absent of kerb ramp creates a trip and fall hazard. Without kerb ramps, pedestrians are unable to access the crossing safely.</p> | <p><u>Severity:</u><br/>Minor</p> <p><u>Likelihood:</u><br/>Likely</p> <p><u>Outcome:</u></p> | Install compliant kerb ramps on both sides of all pedestrian crossings where absent, in accordance with AS 1428. Ensure ramp gradient does not exceed 1:8 (preferred 1:10) and ramp width is a minimum of 1.2 m (preferred 1.5 m). Provide tactile ground surface indicators (TGSIs) | <p><u>Severity:</u><br/>Moderate</p> <p><u>Likelihood:</u><br/>Rare</p> <p><u>Outcome:</u></p> | This mitigation measure is proposed as a short-term solution. In | 3 |

| | | | <p>At Kellas Street carpark:</p> | <p>Medium</p> <p>at the top of kerb ramps (where required) in accordance with AS 1428.4.1. Ensure kerb ramp alignment is consistent with the pedestrian crossing path.</p> <p><i>This mitigation measure is proposed for short term basis. In long term basis, all zebra crossings at the site are proposed to upgrade into wombat crossings.</i></p> | <p>Low</p> | <p>long term, all zebra crossings at the site should be upgraded to wombat crossings to improve pedestrian safety.</p> | |

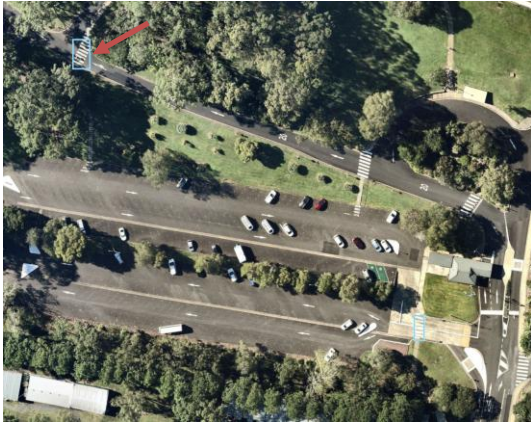
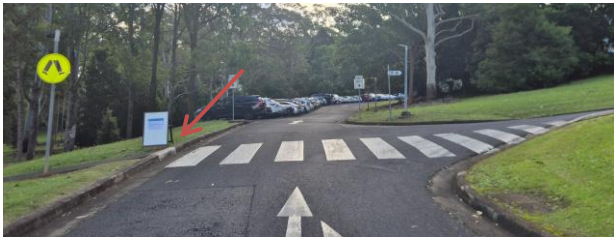
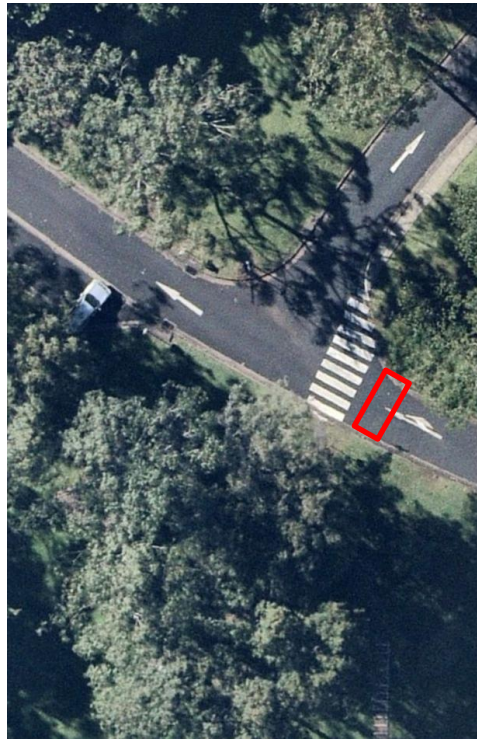
| 10 | Mis-alignment of Pedestrian Crossing and Kerb Ramp | Area 12 | <p>At Area 12, the alignment of the pedestrian crossing and the associated kerb ramps are not consistent, meaning the direct pedestrian path across the crossing does not align with the ramp entry/exit points. This creates a situation where pedestrians, particularly those using wheelchairs or prams are directed off the crossing path. Additionally, as this route is used by buses, the current pedestrian crossing alignment may present safety concerns for pedestrian movement.</p> | <p><u>Severity:</u><br/>Minor<br/><u>Likelihood:</u><br/>Likely<br/><u>Outcome:</u><br/>Medium</p> | <p>Reconstruct the kerb ramps at Area 12 to achieve correct geometric alignment with the pedestrian crossing path, in accordance with AS 1428. Reposition the pedestrian crossing markings as necessary to align with the corrected kerb ramp position and maintain the appropriate offset from the intersection. Ensure TGS1 and its placement is consistent with the realigned crossing.</p> | <p><u>Severity:</u><br/>Moderate<br/><u>Likelihood:</u><br/>Rare<br/><u>Outcome:</u><br/>Low</p> | <p>This mitigation measure is proposed as a short-term solution. In the long term, all zebra crossings at the site should be upgraded to wombat crossings to improve overall pedestrian safety.</p> | 3 |

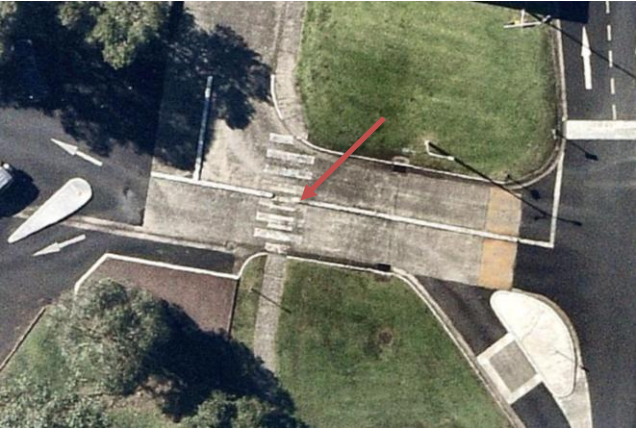
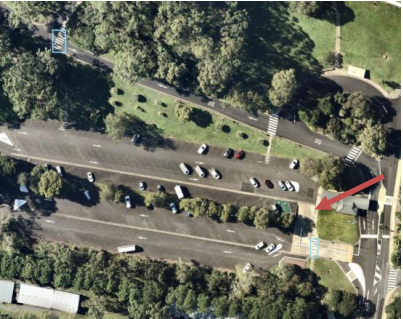
| 11 | Reduced Pedestrian Crossing and misaligned kerb ramp | Area 12 | <p>Additionally, the zebra crossing at the access of the carpark entry at Area12 has reduced opening at the location of the median. Also, it is not correctly aligned to the kerb ramp and also the pavement marking is faded.</p> | <p><u>Severity:</u><br/>Minor<br/><u>Likelihood:</u><br/>Likely<br/><u>Outcome:</u><br/>Medium</p> | <p>Reconstruct the kerb ramps at Area 12 to achieve correct geometric alignment with the pedestrian crossing path, in accordance with AS 1428. Median is to be removed at the location of the pedestrian crossing to achieve required full width crossing. Alternatively, widen the access to provided 1.2m wide island. Additionally, provide the clear directional pavement markings for guide the drivers.</p> | <p><u>Severity:</u><br/>Moderate<br/><u>Likelihood:</u><br/>Rare<br/><u>Outcome:</u><br/>Low</p> | <p>This mitigation measure is recommended for implementation in the near future.</p> | 3 |

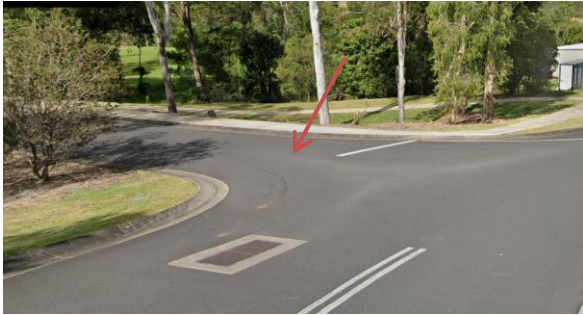
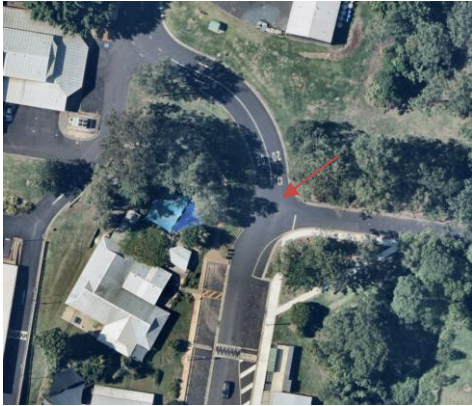
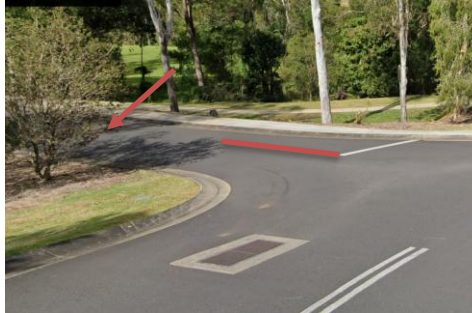
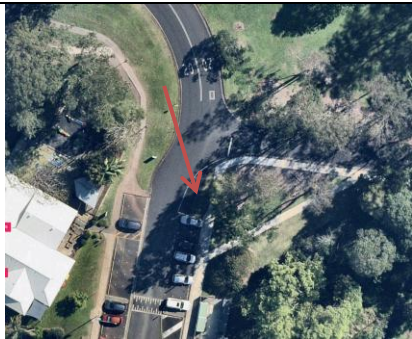
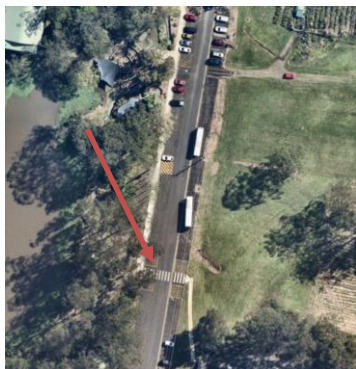
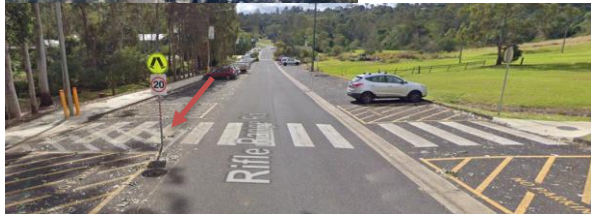
| 12 | Missing Speed Limit Signs or pavement marking and Non-Standard Line Marking | Area 1 Access; Rifle Range Road (Area 2) | <p>At the Area 1 access point, no speed limit signage or pavement speed marking (20 km/h) is provided at the entry. This may cause confusion for drivers regarding the applicable speed on this road. Additionally, the stop line marking does not conform to AS 1742.2.</p> <p>On Rifle Range Road (Area 2), adjacent to a childcare centre and school, there is an absence of speed limit signs, speed limit pavement marking, and directional signage in both directions of travel.</p> | <p><u>Severity:</u><br/>Minor<br/><u>Likelihood:</u><br/>Unlikely<br/><u>Outcome:</u><br/>Low</p> | <p>Install speed limit signs (20 km/h) at Area 1 access and on Rifle Range Road in accordance with AS 1742. Also, provide 20 km/h pavement speed legend markings at appropriate intervals.</p> <p>Reconstruct the stop line marking at Area 1 access as shown below:</p> <p>Install speed limit signs (20 km/h) at Area 1 access and on Rifle Range Road. Provide directional signage or pavement marking in both directions on Rifle Range Road along with speed limit signage.</p> | <p><u>Severity:</u><br/>Minor<br/><u>Likelihood:</u><br/>Rare<br/><u>Outcome:</u><br/>Negligible</p> | <p>This mitigation measure is not limited to the location shown and applies to all the access locations of the precinct.</p> <p>Speed limit signs (20 km/h) are required to be installed at all access points of the precinct. Additionally, where a one-way road connects to a two-way road, directional arrow markings are required.</p> | 3 |

On Rifle Range Road (south of Area 2), there is an absence of speed limit pavement marking. Although a 20 km/h speed limit sign is currently installed, it is not supported by a traffic island, making it vulnerable to potential vehicle impact.

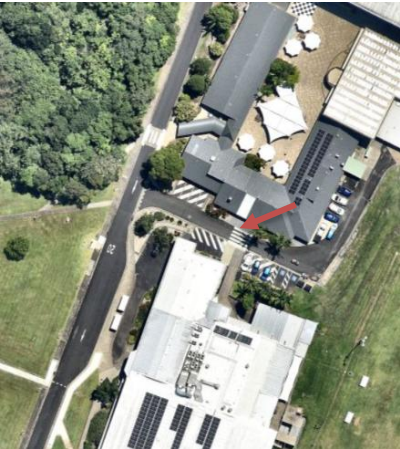
| 13 | Sight Distance Obstruction at Pedestrian Crossing | Area 8 | <p><i>Maintenance Issue:</i> Vegetation adjacent to the pedestrian crossing at Area 8 obstructs driver sightlines to pedestrians approaching or waiting to cross. While the posted speed limit is low, the sight obstruction reduces effective reaction time and may prevent drivers from identifying pedestrians in time to stop safely.</p> | <p><u>Severity:</u><br/>Minor<br/><u>Likelihood:</u><br/>Unlikely<br/><u>Outcome:</u><br/>Low</p> | <p>Trim or remove vegetation within the required sight triangle at Area 8, ensuring clear sight distance is available.</p> <p>Implement a vegetation management plan for ongoing maintenance of sightlines at all pedestrian crossing locations.</p> <p><i>Long term option would be to close off access to the rear car park, which would mean that vehicles would not cross the pedestrian desire line at this location. The then redundant parking area to the rear could be utilised for facilities for the athletics track development or extensions to the existing plaza.</i></p> <p>Additionally, introduce no through road sign visible at the entry from Military Road.</p> | <p><u>Severity:</u><br/>Minor<br/><u>Likelihood:</u><br/>Rare<br/><u>Outcome:</u><br/>Negligible</p> | <p>This mitigation measure is to be implemented as part of ongoing site maintenance. Long term option to be considered.</p> | 4 |

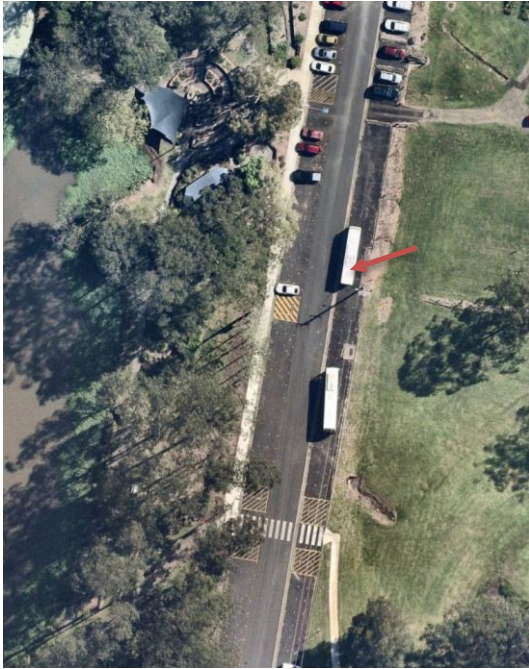
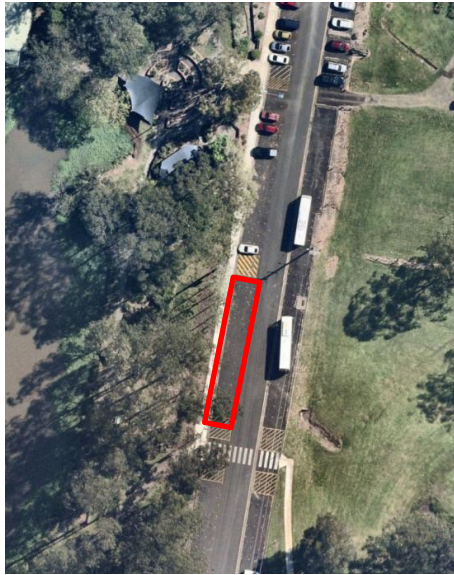
| 14 | Bus Parking Location | Riffle Range Road | <p>On Riffle Range Road, buses are parked facing the opposite direction of traffic, which may create safety risks during entry and exit from the parking space, as well as for other vehicles travelling along this section of road.</p> | <p><u>Severity:</u><br/>Minor<br/><u>Likelihood:</u><br/>Unlikely<br/><u>Outcome:</u><br/>Low</p> | <p>Minimum two buses can be accommodated on the opposite side of the road where parking aligns with the direction of bus entry and exit movements. This arrangement would improve manoeuvrability, reduce conflicts with through traffic, and enhance overall safety for both bus operations and other road users.</p> | <p><u>Severity:</u><br/>Minor<br/><u>Likelihood:</u><br/>Rare<br/><u>Outcome:</u><br/>Negligible</p> | | 4 |

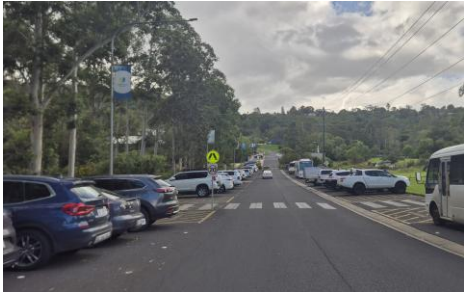
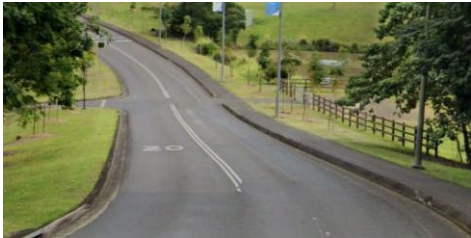
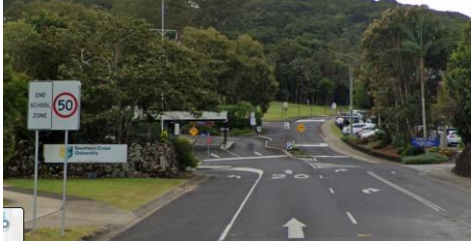
| 15 | Site Entry Signage and road marking | Riffle Range Road, University Road and Military Road | <p>The campus has a speed limit of 20 km/h. The campus entries via Riffle Range Road, University Road and Military Road currently include either 20 km/h pavement markings or speed limit signage. However, to provide consistent and clear guidance to drivers, both 20 km/h speed limit signage and pavement markings are to be provided.</p> <p>Riffle Range Road (missing pavement marking speed limit):</p> <p>University Road (missing speed limit signage):</p> <p>Military Road (missing speed limit signage):</p> | <p><u>Severity:</u><br/>Minor<br/><u>Likelihood:</u><br/>Unlikely<br/><u>Outcome:</u><br/>Low</p> | <p>20 km/h speed limit signage is to be provided at the site entries via University Road and Military Road, while 20 km/h pavement markings are to be provided at the site entry via Riffle Range Road. Additionally, both 50 km/h speed limit signage and pavement markings are to be provided at the site exits.</p> <p>Sign at the entry to the campus:</p> <p>Sign at the exit from the campus:</p> | <p><u>Severity:</u><br/>Minor<br/><u>Likelihood:</u><br/>Rare<br/><u>Outcome:</u><br/>Negligible</p> | This mitigation applies to all entries to the site. | 3 |

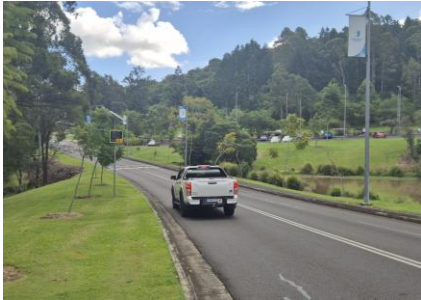
| 16 | Solar powered Digital Speed limit sign | University Road near Area 1 | <p>It was observed that whilst the speed limit of the campus is 20kph, the solar powered digital speed check sign on University Road is set incorrectly to advise drivers to obey a 40kph speed limit, immediately before the location where the 20kph speed limit starts.</p> | <p><u>Severity:</u><br/>Minor<br/><u>Likelihood:</u><br/>Unlikely<br/><u>Outcome:</u><br/>Low</p> | Reconfigure the solar powered digital speed limit sign to read 20kph to minimise confusion of correct speed. | <p><u>Severity:</u><br/>Minor<br/><u>Likelihood:</u><br/>Rare<br/><u>Outcome:</u><br/>Negligible</p> | This mitigation measure is recommended for implementation in the near future. | 2 |
